# **Windows Unified Driver User Guide**

**VeriFone, Inc.**, <http://www.verifone.com>

# Revision 0.1.1

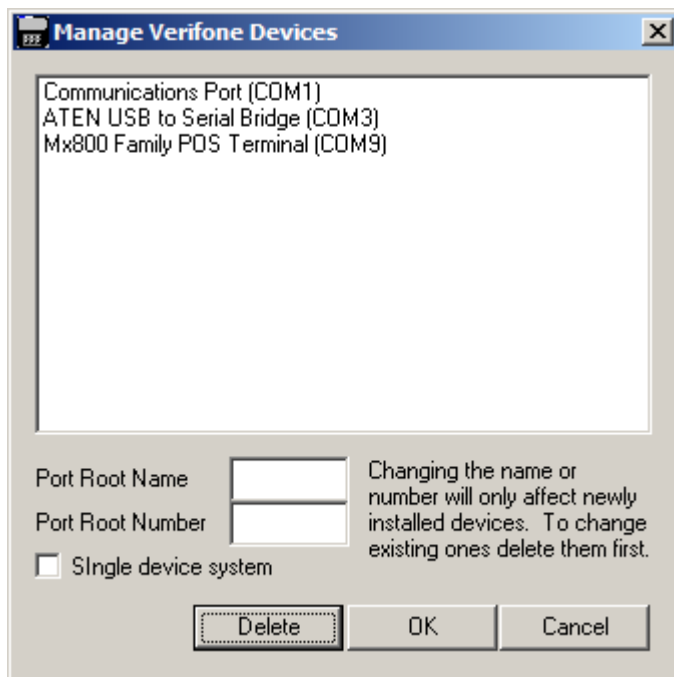
Run Verifone Device Manager

This shows all the communication ports on the machine, whether the devices are connected or not.

Selecting one of them, and clicking Delete, removes that device from the system. If it is a Verifone device the number it is using is liberated and will be reused by any new devices installed.

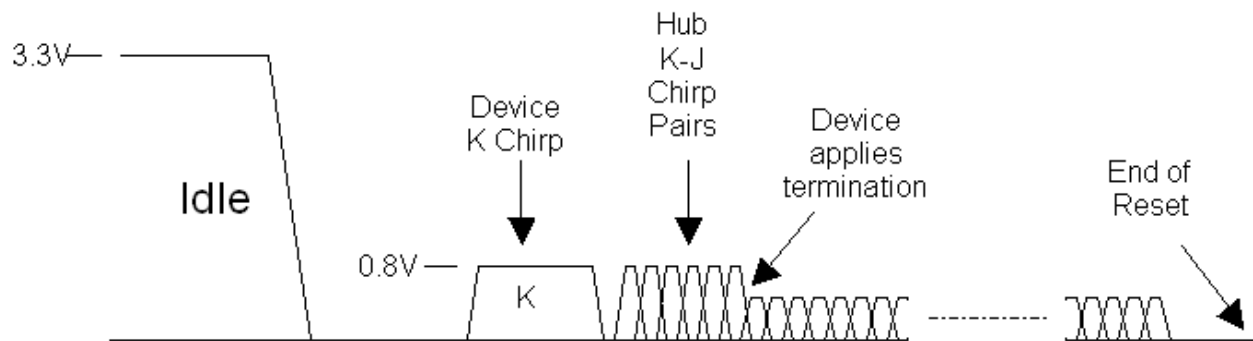
When a USB device is inserted into a host, PC for example, it shows up as a Full Speed device because its D+ line is pulled up to 3volts. To indicate it is a High Speed device, during the mandatory Reset, when the host pulls D+ and D- low, the device applies a lower voltage to the D- line for a period of time. This is called a Chirp-K. If the host is High Speed capable, it sees this, and replies with a stream of Chirp-Js and Chirp-Ks (alternating low voltage on D- and D+). The host copies the device in applying a different resistor to the D+ line resulting in a 500 millivolt differential which is High Speed.

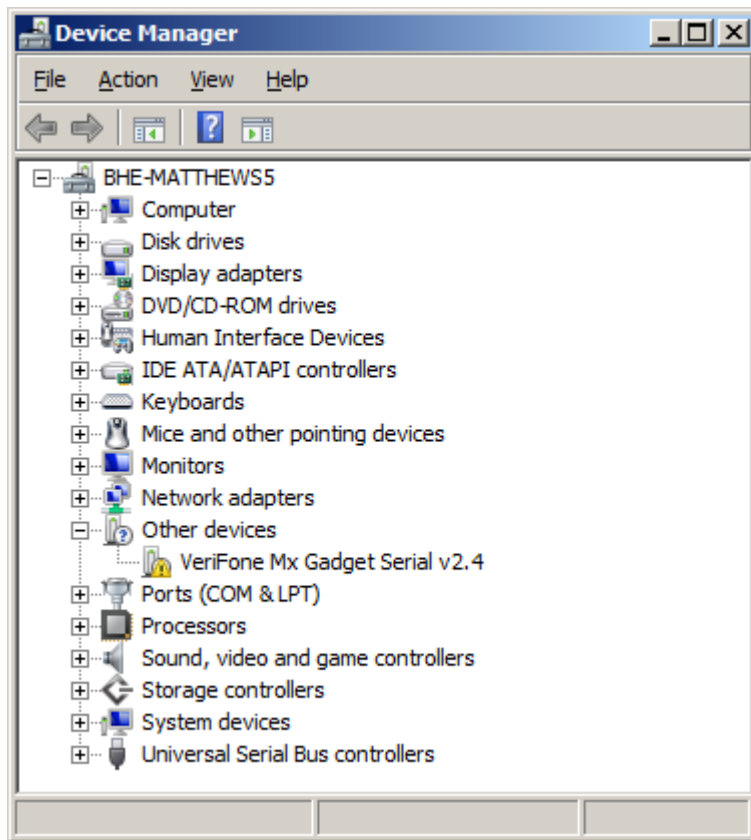
This is what Devicemanager will show if enumeration is successful:

If it is not successful then 'Unrecognised Device' will be displayed instead of 'Verifone Mx Gadget v2.4'. So, if you see 'Unrecognised Device' you know the failure was in the hardware enumeration.

If you do see 'Verifone Mx Gadget v2.4' then you know the hardware enumerated correctly, but that the drivers are not installed.

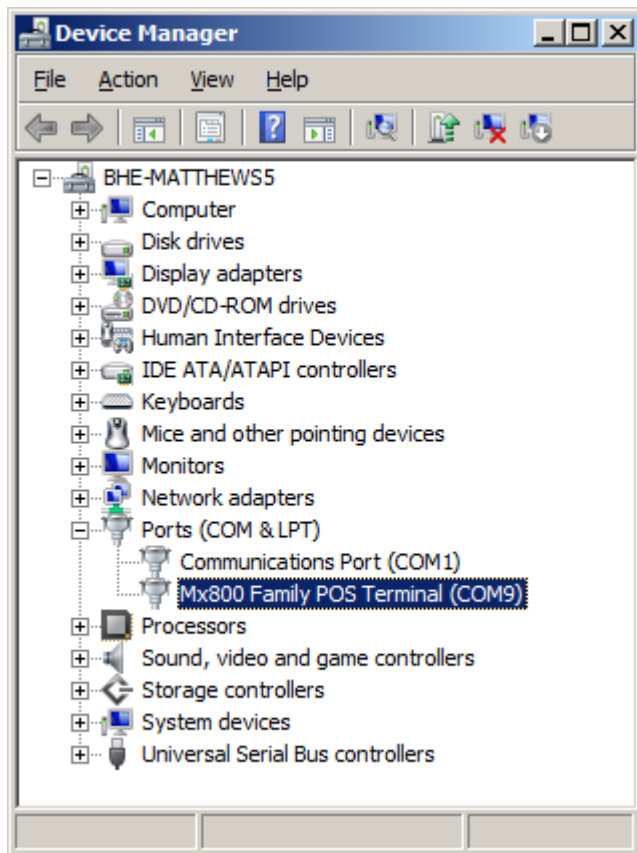
When the system has all this information, and has registered this hardware with the information in the inf file, Devicemanager will look like this:

Depending of course on what device you are using, and what port name and base number was chosen during the install.

At this stage all is good and the application can open that port and begin communicating with the device.
